**THERMAL PERFORMANCE AND DELIVERY CAPABILITY OF A 220 L
HYBRID POLYMER STEEL CONSTRUCTION ELECTRIC WATER HEATER**

job	file	date	report no.
12-144	814	January 24, 1991	91-16-K

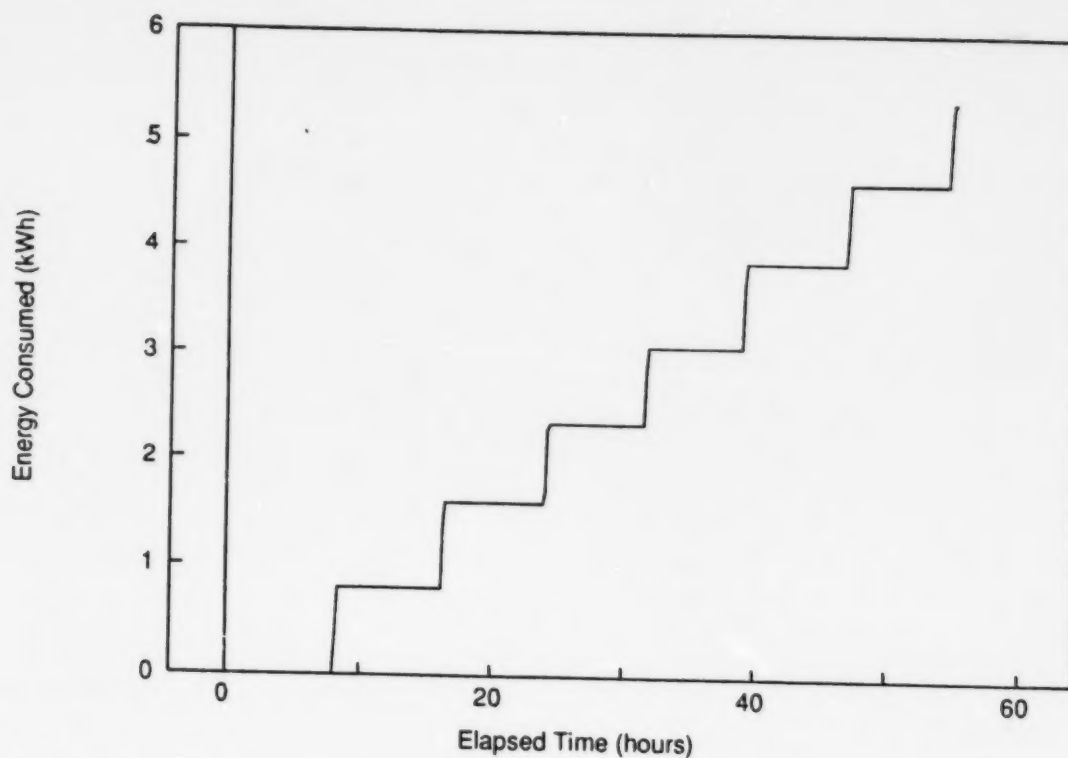
Figure 1 - Energy Efficiency Test

The energy efficiency test results are graphically illustrated in Figure 1. The standby loss for this tank was 98.6 W. The new CSA standard allows for a loss of up to 105 W; consequently, this tank passed the requirements of this test.

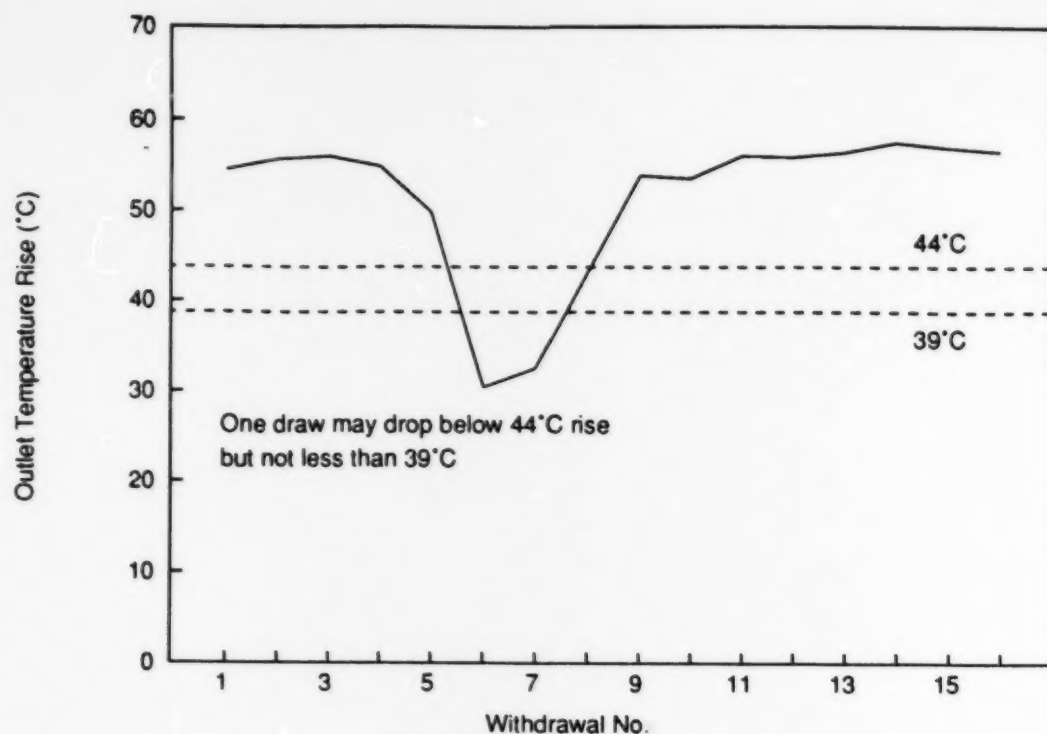
Figure 2 - Delivery Test

The hot water delivery requirements were not met by this tank. The tank was unable to maintain the standard delivery temperature when subject to 16 daily withdrawals totalling 454 L (Table 2). The lower thermostat of the tank was set for a 56°C rise above the inlet temperature of 18°C, as required in the standard. The upper thermostat was not adjustable, and therefore could not be set to the required temperature. A water heater is deemed to have failed a delivery schedule if the difference between the average outlet temperature and the inlet temperature drops below 44°C, except that one draw may drop to 39°C above the inlet temperature. Figure 2 is a differential graph which shows the average outlet temperature minus the inlet temperature (*outlet temperature rise*) during the draws.

It appears from the data that the top element did not operate during the delivery test. This is attributed to the low setpoint of the upper thermostat (49.5°C) in relation to the water temperature requirement for the test (74°C). Use of an upper thermostat with a higher setpoint may improve the performance of the tank during the delivery test.

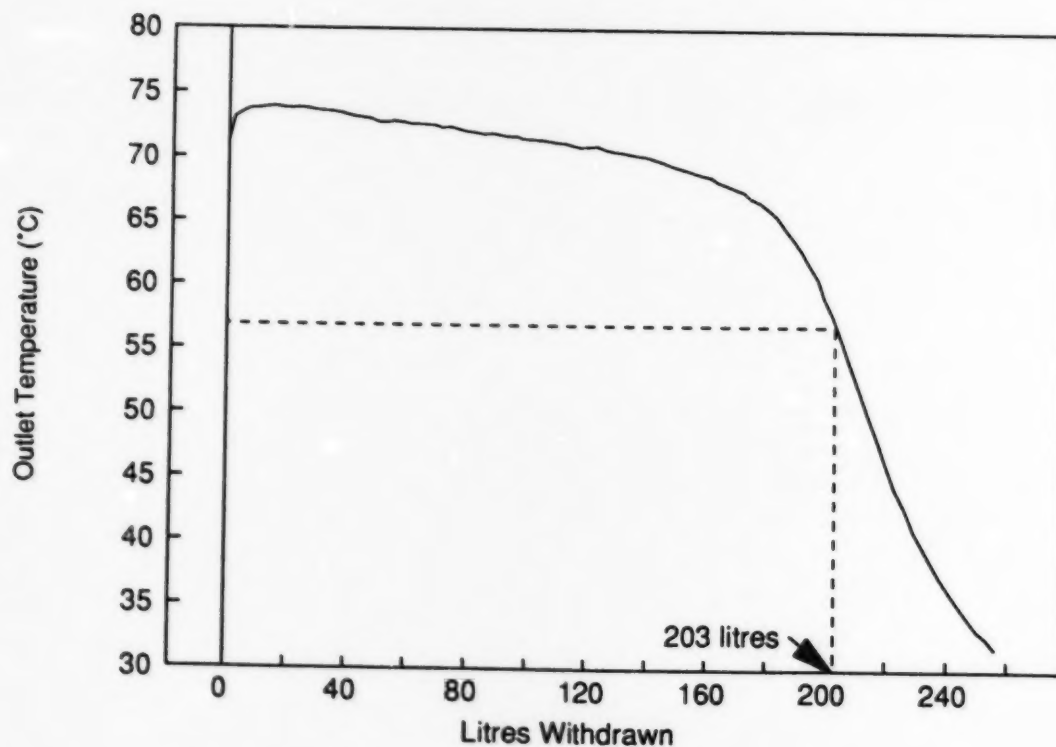
Figure 3 - Diffusion Test

The diffusion test indicated that the percentage of the total tank volume of hot water delivered before the outlet temperature dropped 17°C below the setpoint was 92% (203 L). The minimum requirement for this test is 90% (198.5 L). Consequently, the tank passed this test. Figure 3 shows the results of this test graphically.

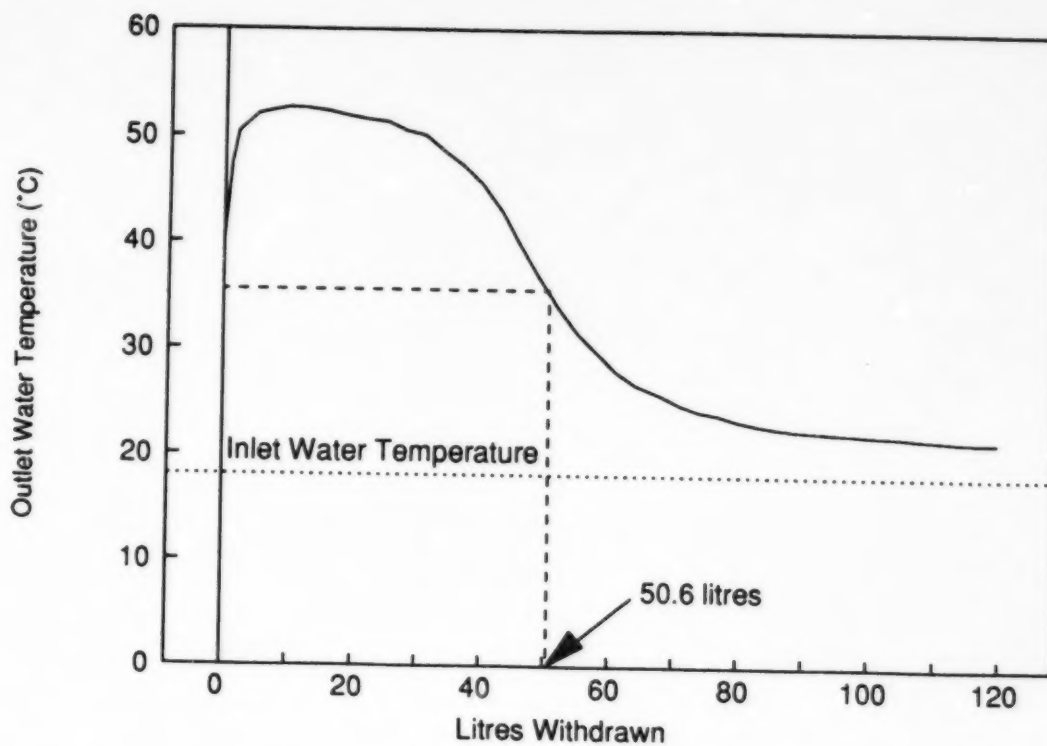
Figure 4 - Upper Zone Test

The upper zone test determines the volume of water heated by the top element. The test is conducted on a cold tank with the lower element disabled. The upper element is operated until cycling off thermostatically. The thermostat is supposed to be set for a 56°C rise above the inlet temperature. For the tank tested, the thermostat was not adjustable, and had a setpoint of about 49.5°C. Water was drawn off at 18 L/min, until the outlet water temperature dropped 17°C below setpoint. Figure 4 shows that 50.6 L (23% of the total tank capacity) of hot water were provided by the tank before the discharge temperature declined 17°C. The CSA requirement is $25 \pm 2.5\%$ of the tank volume for a 175 L tank; in this case 55 ± 5.5 L. This tank passed the CSA requirement.
